## FEROBIDE PROTECTS IRON ORE SPOON CHUTE FROM SEVERE ABRASIVE WEAR

Customer: Major Canadian Mining Company

Application: Iron Ore Spoon Chute

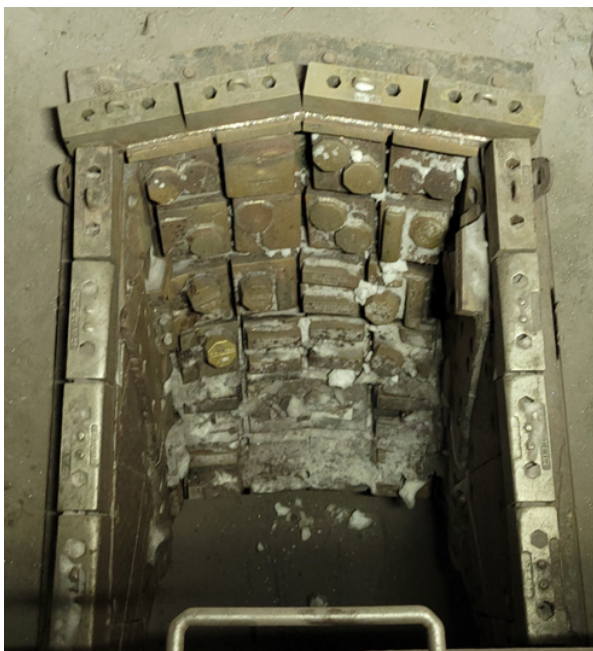
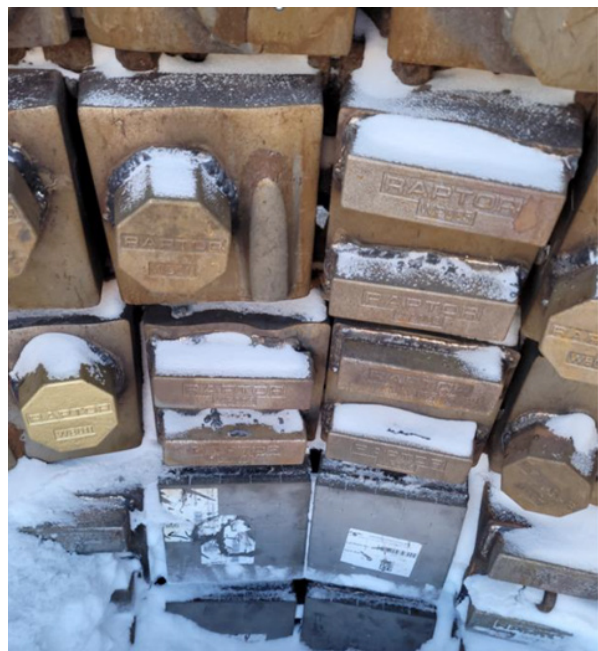
- Bars had completely worn away.
- Significant material loss was evident in the highest wear zones.
- Replacement would have been required.

- Plates remained intact and continued to provide effective wear protection.
- Minimal wear was observed despite exposure to the same operating conditions.
- Continued service life beyond the evaluation period was achieved.

After processing 5 million tonnes of iron ore, the cast white iron wear plates had completely worn away, while the FEROBIDE® plates in the highest wear area remained intact and continued to perform effectively.
